**Mountain District Office**

**General Storm Water NPDES Permit Evaluation Report**

| Project Name: | Lake Arrowhead Phase 2 Unit 12 | Permittee Name: | Lake Arrowhead Communities, LLC |

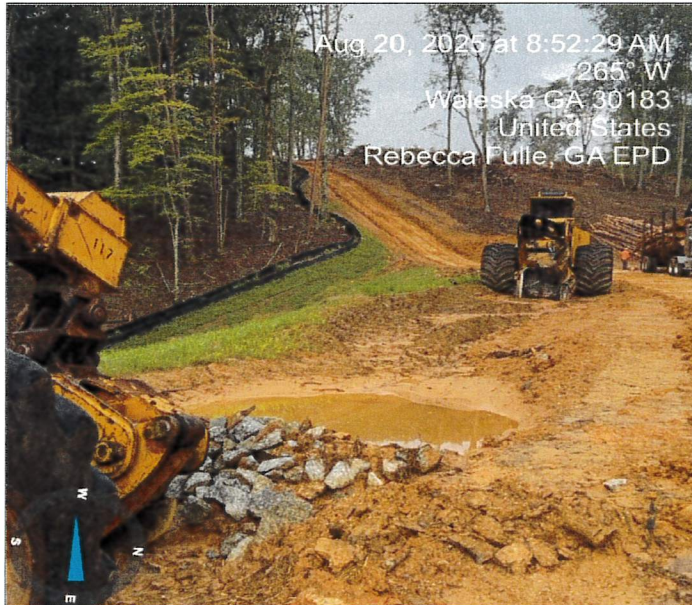
**Photo Number:** 1 of 6  
**Date:** 08-20-25  
**Photographer:** Rebecca Fulle  
**Location:** Site, facing West  
**Observations:** Heavy machinery parked on top of a diversion.

- BMPs must be installed and maintained according to the ESPCP and Part III.D of the Permit. If BMPs continue to fail and sediment continues to discharge from the Site, unless during a 25-year rain event or greater, the Site should stop work and the ESPCP must be revised to correct noncompliance and to retain sediment onsite in accordance with Part IV.C of the Permit. If plan revisions are required, all construction activity at the Site should stop except those necessary to install and maintain BMPs, and the design professional should inspect the Site after new BMPs are installed and submit a new 7-day letter before any other construction activity at the Site is allowed to resume.

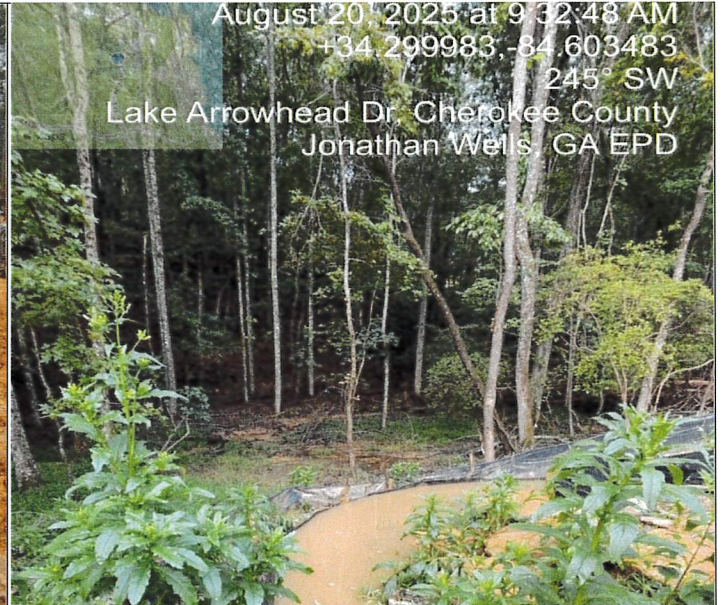
**Photo Number:** 2 of 6  
**Date:** 08-20-25  
**Photographer:** Jonathan Wells  
**Location:** Site, facing southwest  
**Observations:** Sediment observed leaving the site outfall.

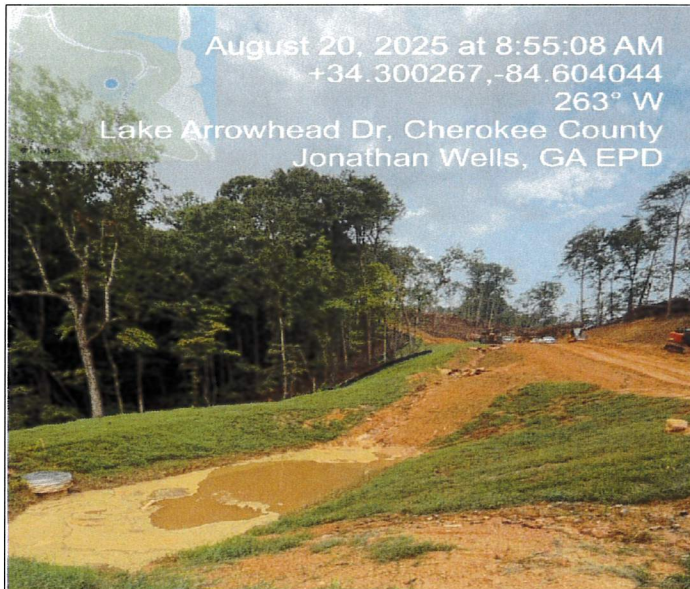
**Photo Number:** 3 of 6  
**Date:** 08-20-25  
**Photographer:** Jonathan Wells  
**Location:** Site, facing West  
**Observations:** Temporary sediment basin requires maintenance.

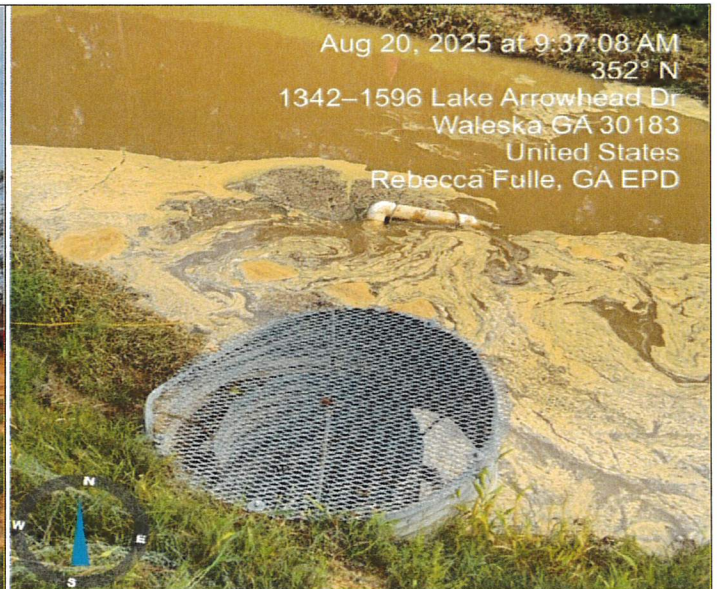
**Photo Number:** 4 of 6  
**Date:** 08-20-25  
**Photographer:** Rebecca Fulle  
**Location:** Site, facing North  
**Observations:** Surface skimmer requires maintenance.

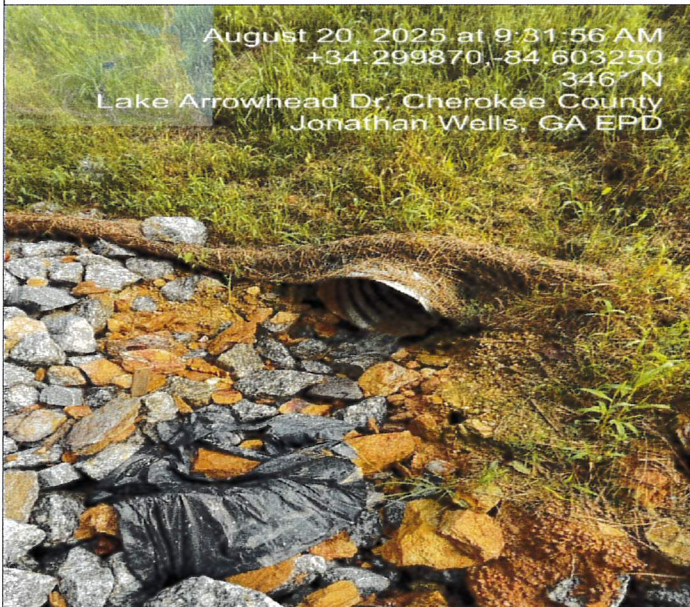
**Photo Number:** 5 of 8  
**Date:** 08-20-25  
**Photographer:** Jonathan Wells  
**Location:** Sediment basin outfall, facing North.  
**Observations:** Sediment observed leaving the site.

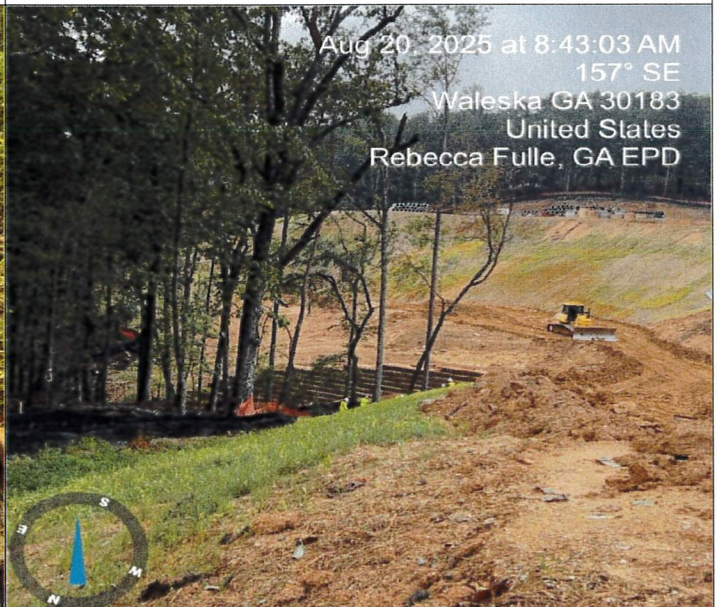
**Photo Number:** 6 of 8  
**Date:** 08-20-25  
**Photographer:** Rebecca Fulle  
**Location:** Site, facing southeast  
**Observations:** Land Disturbance Activity contributing to erosion and sedimentation issues.

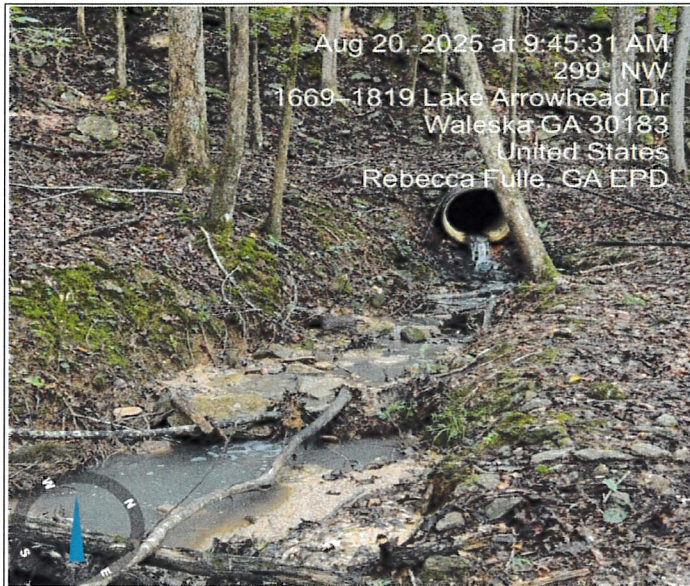
**Photo Number:** 7 of 8  
**Date:** 08-20-25  
**Photographer:** Rebecca Fulle  
**Location:** Tributary near site  
**Observations:** Grey color observed in runoff from Site.

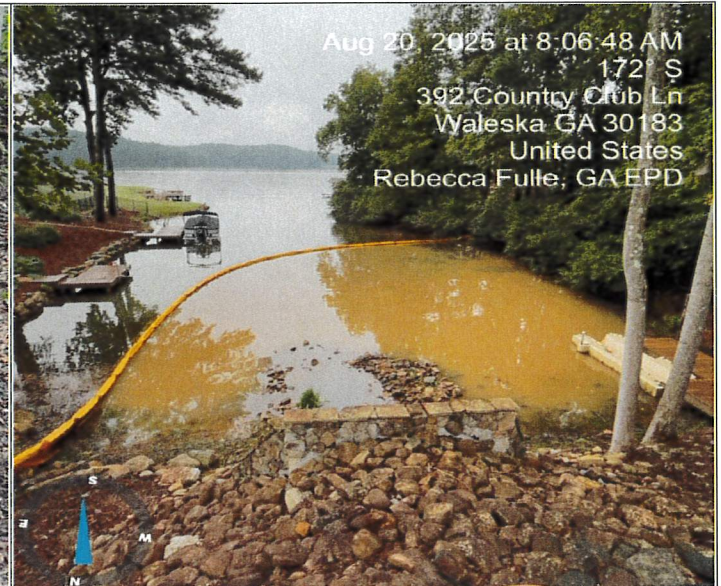
**Photo Number:** 8 of 8  
**Date:** 08-20-25  
**Photographer:** Rebecca Fulle  
**Location:** Cove on Lake Arrowhead  
**Observations:** Sediment impacts to the lake from site runoff.
