## Atlanta Airport Daily Report

**Day** Saturday  
**Date** 2/7/2026

# Atlanta Airport Daily Report Outfall FR-1/AATC

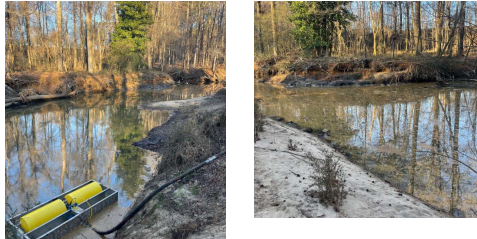
| Activity Log | |
|---|---|
| Start of Day Photos | |

| Activity Log | |
|---|---|
| Due to the shift in the wind the fuel has moved into a pocket, still within boomed area. Skimmers repositioned. | |

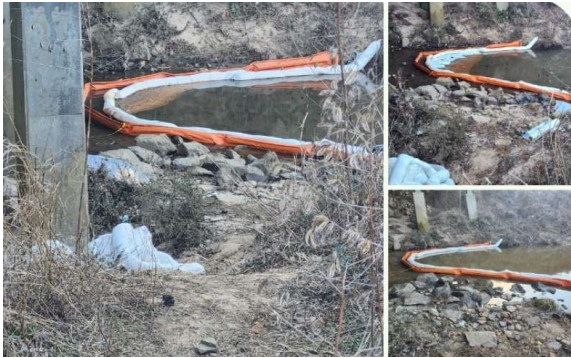
| Activity Log | |
|---|---|
| End of Day Photos | |

| Activity Log | |
|---|---|
| e mode - manual collection. Overnight debris and scum has made its way down, this is being collected manually | |

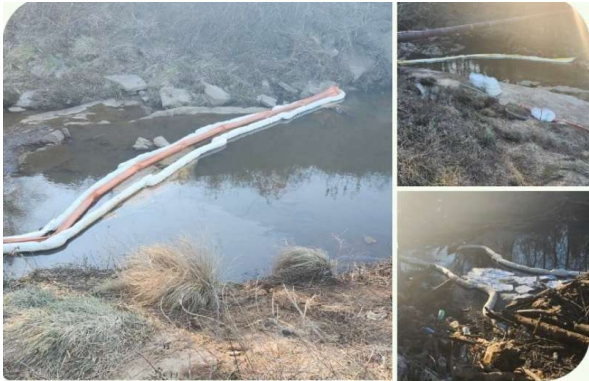
| Activity Log | |
|---|---|
| End of Day Photos | |

| Activity Log | |
|---|---|
| Manual collection of debris. Some debris has made its way downstream and is being collected this morning. | |

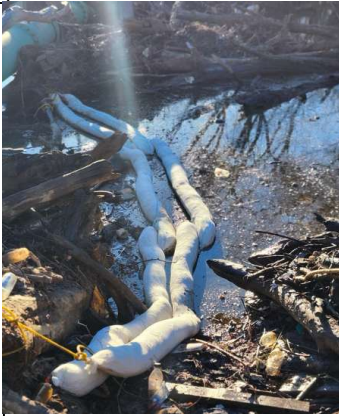
| Activity Log | |
|---|---|
| The boat is in the water. 200 bags of litter and debris collected, to be disposed in a roll-off. Contaminated and covered limbs and branches are collected on the river bank for disposal into the roll-off bin. | |

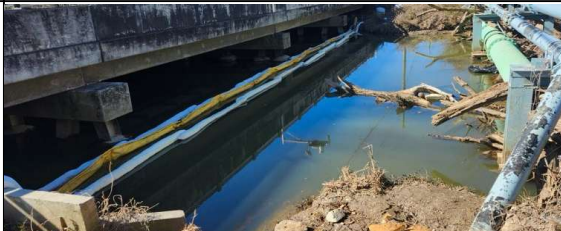
| Activity Log | |
|---|---|
| End of Day Photos | |

| Activity Log | |
|---|---|
| A - Containment booms deployed and checked (provide status) | Hard and soft booms coraling debris to the north side of the bridge. Frequently changed out. |

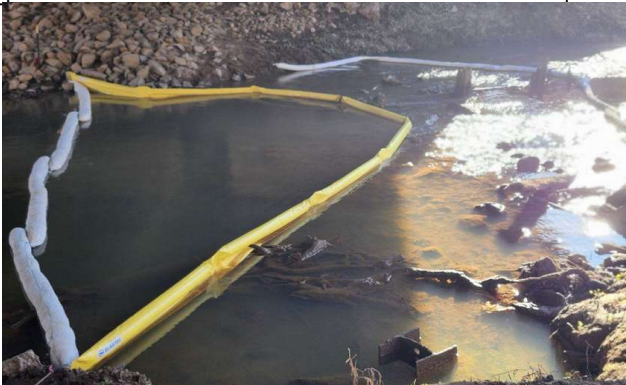
**Start of Day Photos**

Maintenance work

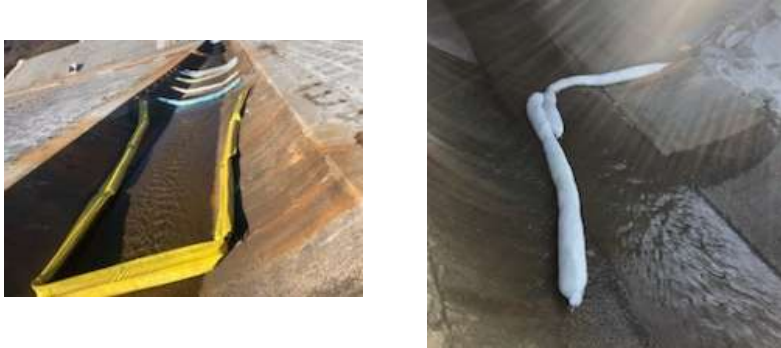
| Activity Log | |
|---|---|
| Start of Day Photos | |

| Activity Log | |
|---|---|
| Maintenance work | |
