**FISH KILL INVESTIGATION:**

Indian Creek  
Franklin County  
Broad River Drainage

By  
Anthony Rabern  
Fisheries Biologist

October 9, 2019

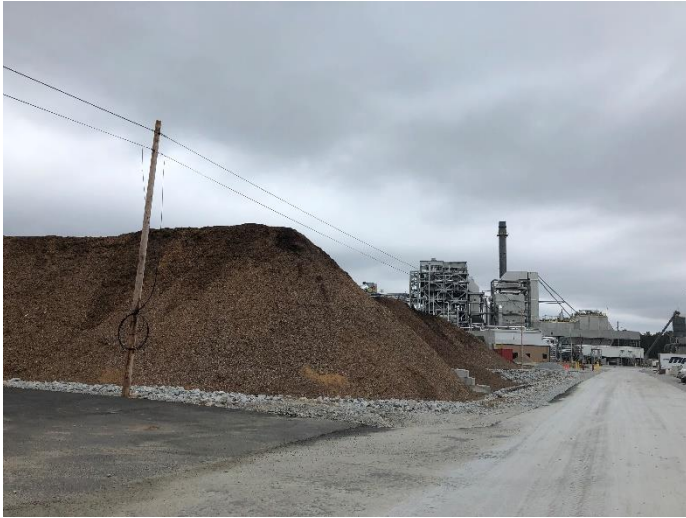
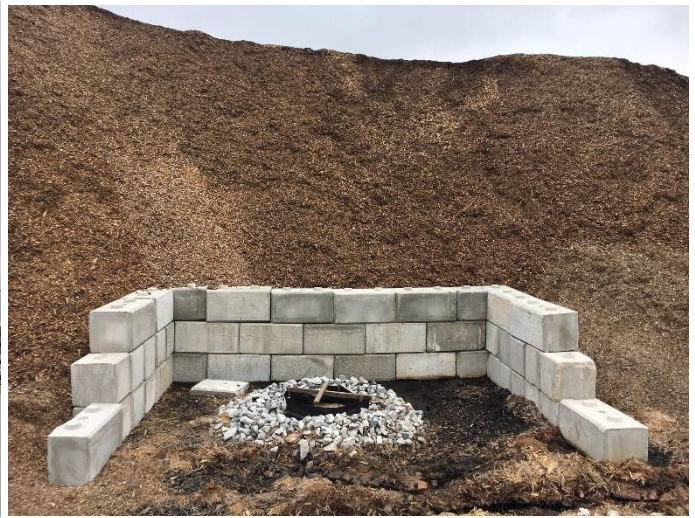
**Photos 1&2.** Large woodpile at the Franklin Biomass Generating Facility. The photo on the right also shows the catch basin for collecting runoff from the woodpile where black residue from recent runoff was noticeable. Photographs were taken by Anthony Rabern on October 6, 2019.

At 1300 hours on October 6, 2019, Mr. Anderson met me at the Franklin Biomass Generating Facility (FBGF). I spoke with the Operations Supervisor, Mr. Scotty Smith ((252) 813-8804), who put me in contact via his cell phone with the Plant Manager, Mr. David Groves ((910) 477-1198). Mr. Groves explained that the wood pile that fuels the generating facility self-combusted on Saturday afternoon (10/5/19). FBGF staff used large-volume water cannons permanently mounted next to the wood pile to suppress the fire with thousands of gallons of water. Runoff from the water-soaked wood pile overwhelmed the stormwater retention system and overflowed into an Unnamed Tributary that originates on the property and eventually flows into Indian Creek (Photos 1-4). While at the facility, I observed a light amount of smoke bellowing from the wood pile. I also observed residual runoff from the wood pile that was black in color.

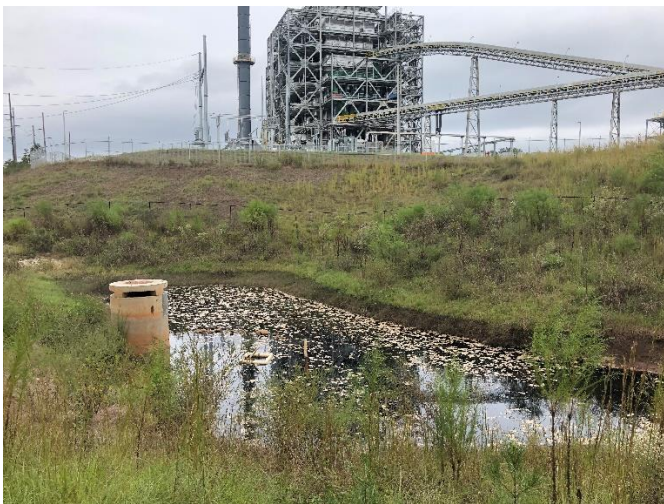
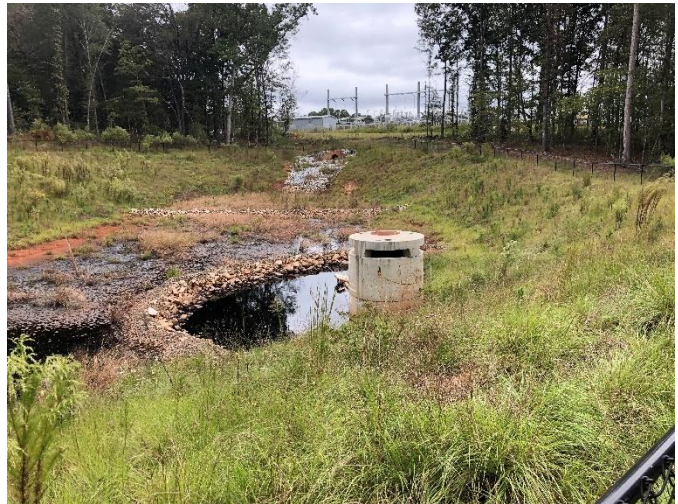
**Photos 3&4.** Two stormwater retention ponds at the Franklin Generating Biomass Facility with each pond containing black water. Photographs were taken by Anthony Rabern on October 6, 2019.

Mr. Anderson and I proceeded to Site 3 (Figure 1), located in the stormwater drainage system, to measure water quality in the black runoff from FBGF. We followed the stormwater retention system downstream and observed black effluent flowing from the retention pond and into the Unnamed Tributary of Indian Creek (Photo 5). The water in the Unnamed Tributary of Indian Creek was black in color and clarity was zero (Photo 6). Because of this black color, we were not able to visually ascertain the presence/absence of aquatic organisms in the Unnamed Tributary of Indian Creek nor use the Hach Kit to measure pH and total hardness. We followed the Unnamed Tributary of Indian Creek downstream for approximately 0.7 miles to its confluence with Indian Creek. Just upstream of the confluence of the Unnamed Tributary of Indian Creek with Indian Creek proper at Site 2 (Figure 1), the water was clear and live fish were abundant (Photo 7). Water quality parameters (temperature, dissolved oxygen, pH, and total hardness) at Site 2 were suitable to support aquatic life and the water chemistry at this location as well as at

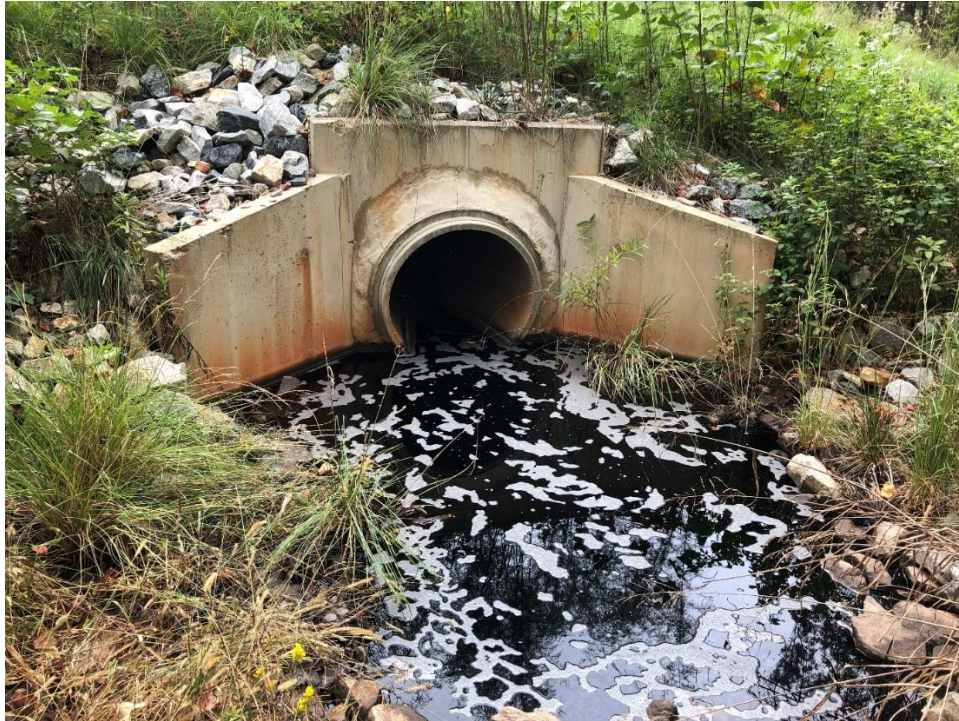
**Photo 5.** Stormwater retention pond outlet at the Franklin Generation Biomass Facility releasing black effluent into the Unnamed Tributary of Indian Creek. Photograph was taken by Anthony Rabern on October 6, 2019.

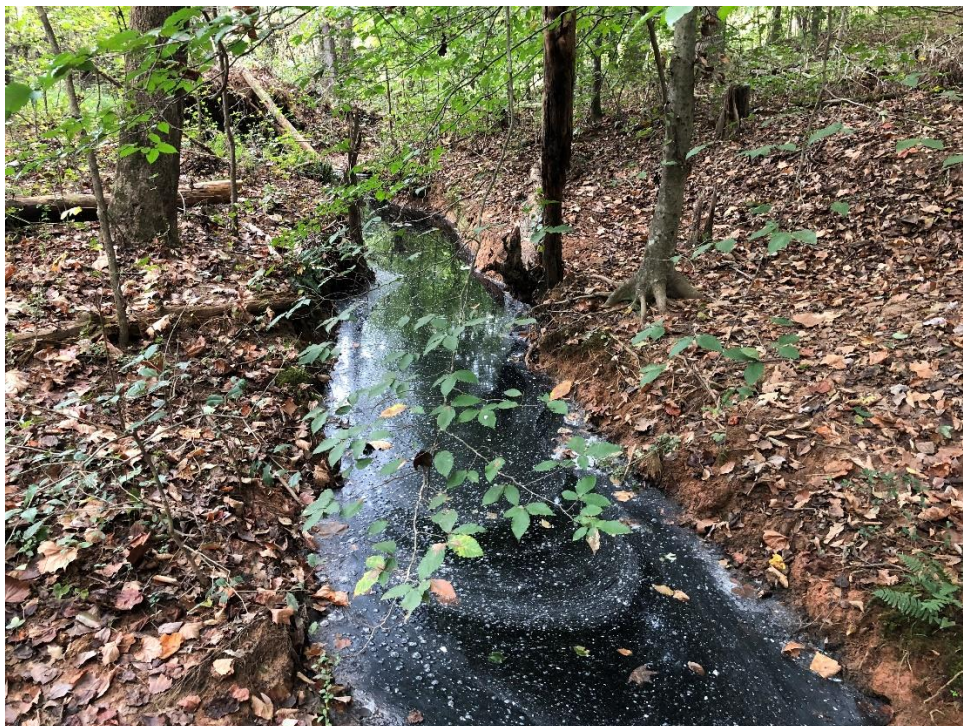
**Photo 6.** Unnamed Tributary of Indian Creek containing black effluent from Franklin County Generating Facility's retention ponds on October 6, 2019. Photograph was taken by Anthony Rabern.

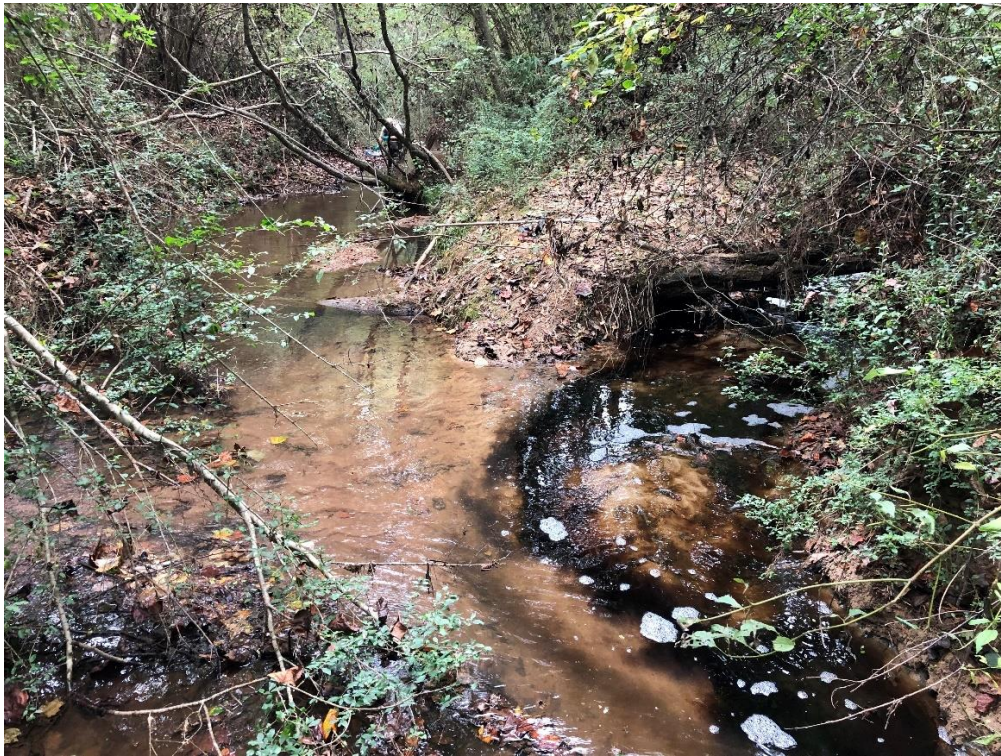
**Photo 7.** Confluence of Indian Creek (left) and the Unnamed Tributary of Indian Creek (right) that drained the Franklin Biomass Generating Facility's retention ponds. Photograph taken by Anthony Rabern on October 6, 2019.

The first fish mortality was observed at Site 4 (Figure 1) in Indian Creek, which was located about 25 m downstream from the confluence with the Unnamed Tributary of Indian Creek. Although Site 2, upstream of the confluence, and Site 4, downstream of the confluence, were only 50 meters apart, a significant change in water quality was measured between these two stations. At Site 4, the pH decreased by four units, total hardness increased by 500% and dissolved oxygen decreased by 1.2 mg/L. In addition, there was a dramatic color change at Site 4 from clear to black and a strong odor like that of burnt wood.

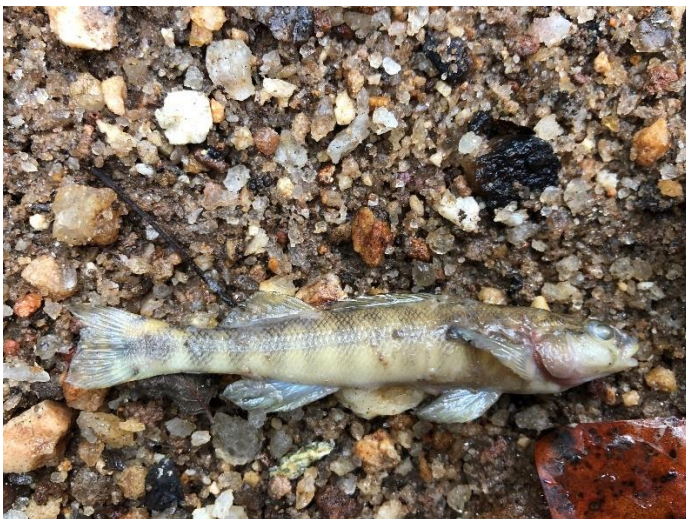
**Photos 8&9.** Fish mortalities collected by Anthony Rabern in Indian Creek downstream of the Unnamed Tributary of Indian Creek on October 6, 2019. Photographs were taken by Anthony Rabern.

Based on the findings from our water quality measurements, visual stream observations and fish counts on October 6, 2019, a total die-off of fish occurred in 4.6 miles of Indian Creek. The fish kill was caused by significant water quality changes in Indian Creek associated with run-off from a smoldering wood pile at FBGF. The resulting black effluent that drained from FBGF into Indian Creek significantly reduced pH and dissolved oxygen concentrations in a very short time period to levels that were potentially lethal to fish in the 4.6-mile impact zone. The total number of fish mortalities in Indian Creek on October 6, 2019 was estimated to be 2,159 fish (Table 2), which included seven species of fish including those pictured in Photos 8 and 9. The total number of fish mortalities was estimated by expanding the total number of fish collected in each 100 m subsample reach over the total distance for each reach. Expanded fish counts were then summed for all subsample reaches to provide a total fish mortality estimate. Using the replacement values of fish reported in Southwick and Loftus (2017), the monetary value of these fish mortalities totaled \$1,428.67. Investigative costs for personnel and vehicles used in this fish kill investigation totaled \$3,366.78 (Table 3). The investigative costs plus monetary value of fish brought the total cost of the fish kill to \$4,795.45.
