**Northeast District**

**Trip Report**

**July 20, 2023:** At 1:30 PM Jamie Lewis, Sam Wood, and I along with Courtney Wilson from the Georgia Department of Agriculture met with the complainant on Williams Creek in Taliaferro County. Upon arrival, the complainant took us to the location downstream from the soil amendment property where he first observed the discolored creek bank and water. Photos 1-8 depict the current state of the creek on the day of the trip similar to the photos submitted by the complainant (Complainant photos submitted to CTS). Next, we went upstream to the property that the complainant believed caused the impacts documented in the creek. This property was a former hog farm that is now being used to store and spread soil amendments. At the soil amendment property, photo 9 depicts the lagoon where the soil amendment is stored. Photos 10-12 depict photos near the lagoon. Photo 10 specifically depicts a photo of discolored water and dark soil similar to photos of the creek downstream from the soil amendment property. An employee on the soil amendment property told us that lagoon is pumped into a tank on a tractor where this photo was taken. Photos 13-18 show a cr

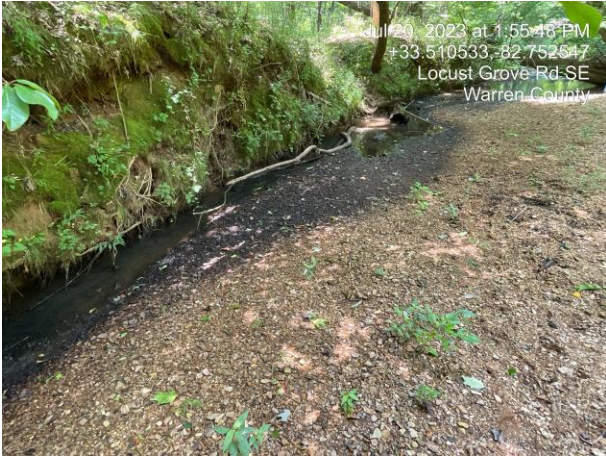
**Photo #1:** 7/20/2023

**Observations:** Significant amount of dark discoloration of creek banks and water. Photo taken downstream of the property applying the soil amendment.

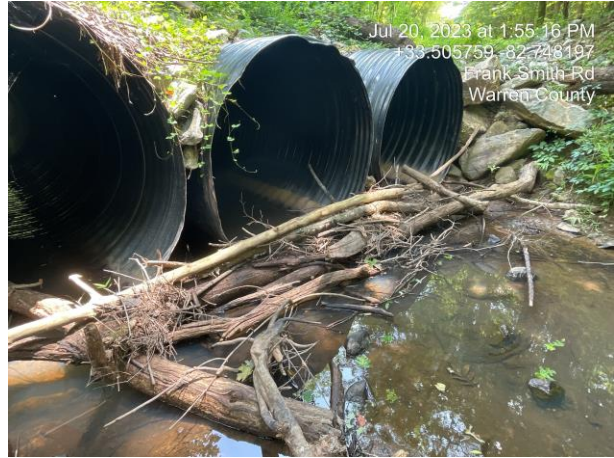
**Photo #2:** 7/20/2023

**Observations:** Significant amount of dark discoloration of water. Photo taken downstream of the property applying the soil amendment.

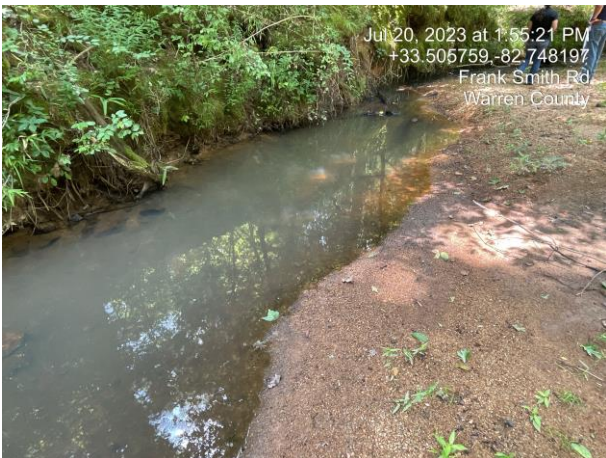
**Photo #3:** 7/20/2023

**Observations:** Significant amount of dark discoloration of water. Photo taken downstream of the property applying the soil amendment.

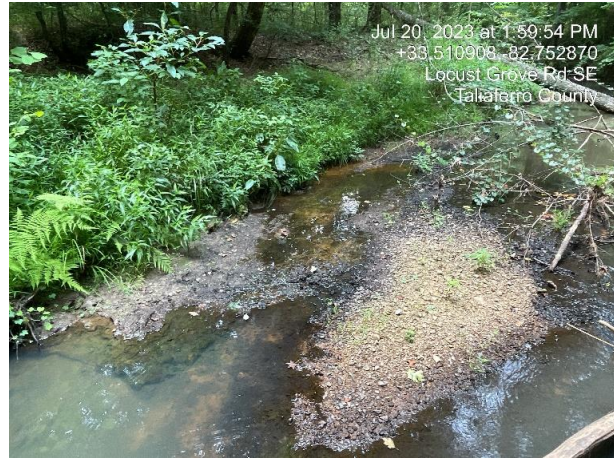
**Photo #4:** 7/20/2023

**Observations:** Significant amount of dark discoloration of creek banks and water. Photo taken downstream of the property applying the soil amendment.

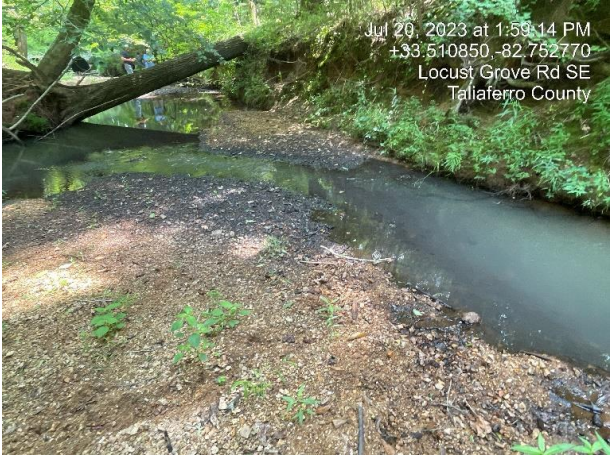
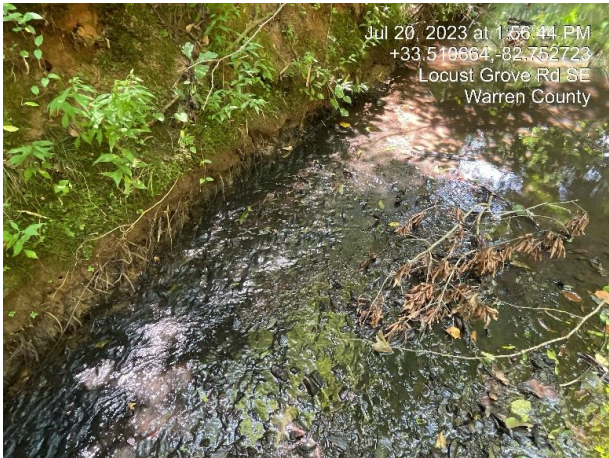
<p><b>Photo #5:</b> 7/20/2023  <b>Photographer:</b> Serenity Cowart  <b>Observations:</b> Significant amount of dark discoloration of creek bed and water. Photo taken downstream of the property applying the soil amendment.</p>	<p><b>Photo #6:</b> 7/20/2023  <b>Photographer:</b> Serenity Cowart  <b>Observations:</b> Significant amount of dark discoloration of water. Photo taken downstream of the property applying the soil amendment.</p>

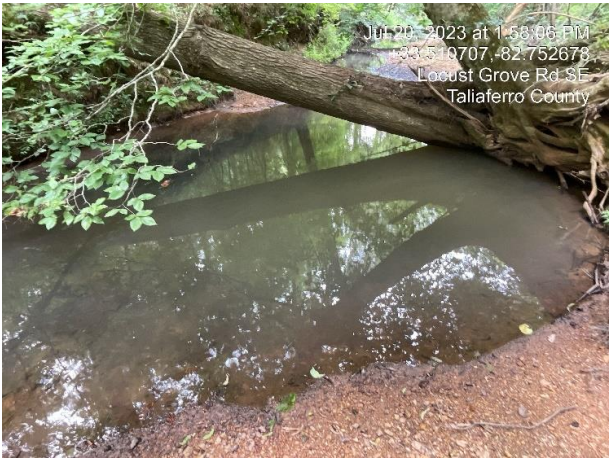
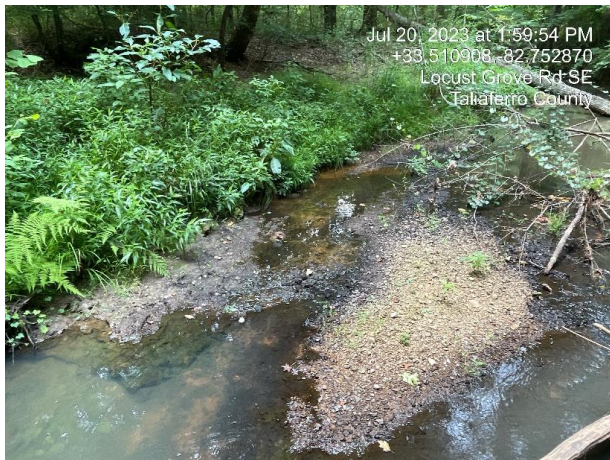
<p><b>Photo #7:</b> 7/20/2023  <b>Photographer:</b> Serenity Cowart  <b>Observations:</b> Significant amount of dark discoloration of water. Photo taken downstream of the property applying the soil amendment.</p>	<p><b>Photo #8:</b> 7/20/2023  <b>Photographer:</b> Serenity Cowart  <b>Observations:</b> Significant amount of dark discoloration of creek bed and water. Photo taken downstream of the property applying the soil amendment.</p>

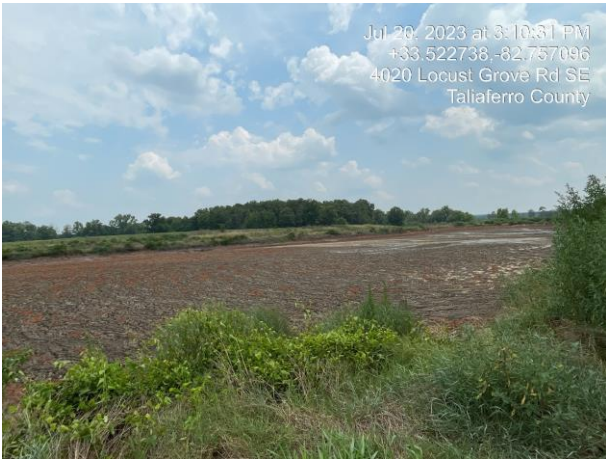
**Photo #9:** 7/20/2023  
**Photographer:** Serenity Cowart  
**Observations:** Photo of the lagoon.

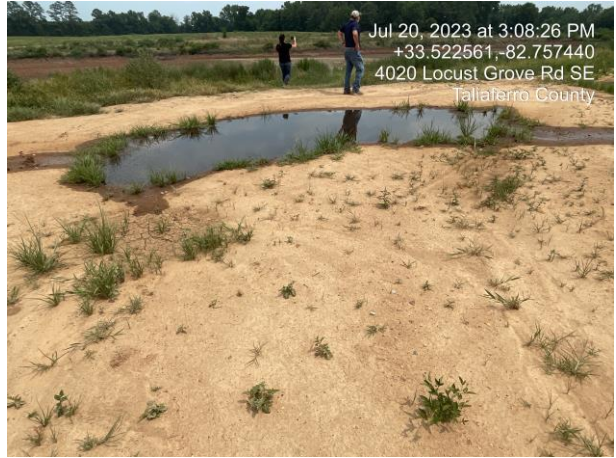
**Photo # 10:** 7/20/2023  
**Photographer:** Serenity Cowart  
**Observations:** Photo near lagoon. An employee informed us that this is where the soil amendment is pumped from the lagoon into the tractor.

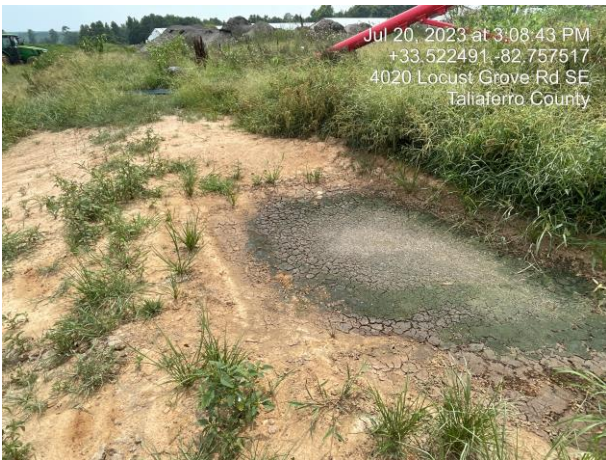
**Photo #11:** 7/20/2023  
**Photographer:** Serenity Cowart  
**Observations:** Photo near lagoon.

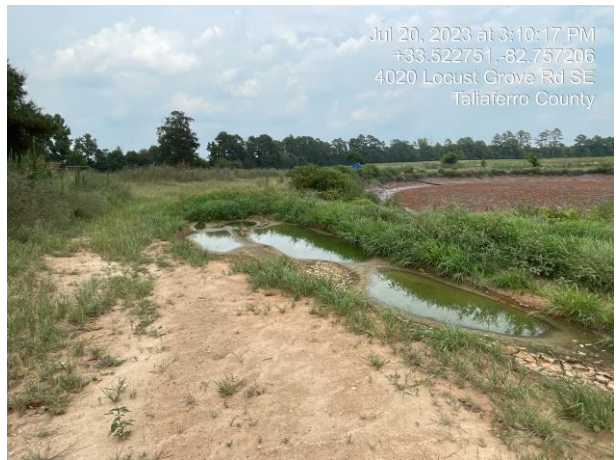
**Photo #12:** 7/20/2023  
**Photographer:** Serenity Cowart  
**Observations:** Photo near lagoon.

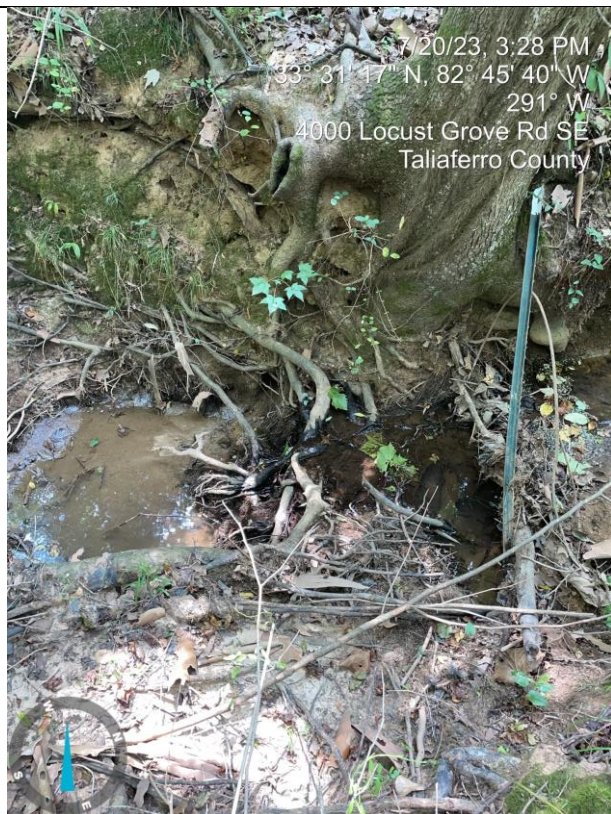
**Photo #13:** 7/20/2023

**Observations:** Photo of creek on the soil amendment property showing discolored creek banks and waters.

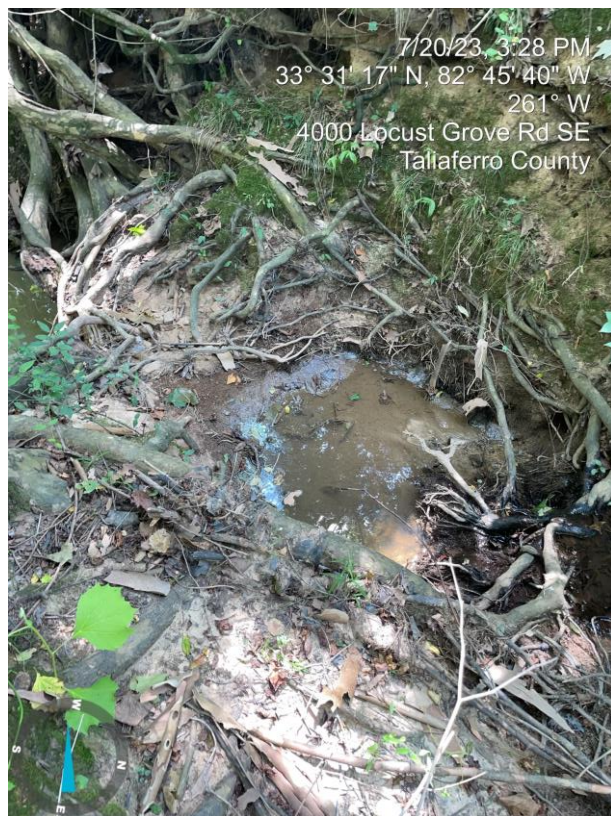
**Photo #14:** 7/20/2023

**Observations:** Photo of creek on the soil amendment property showing discolored creek banks and waters.

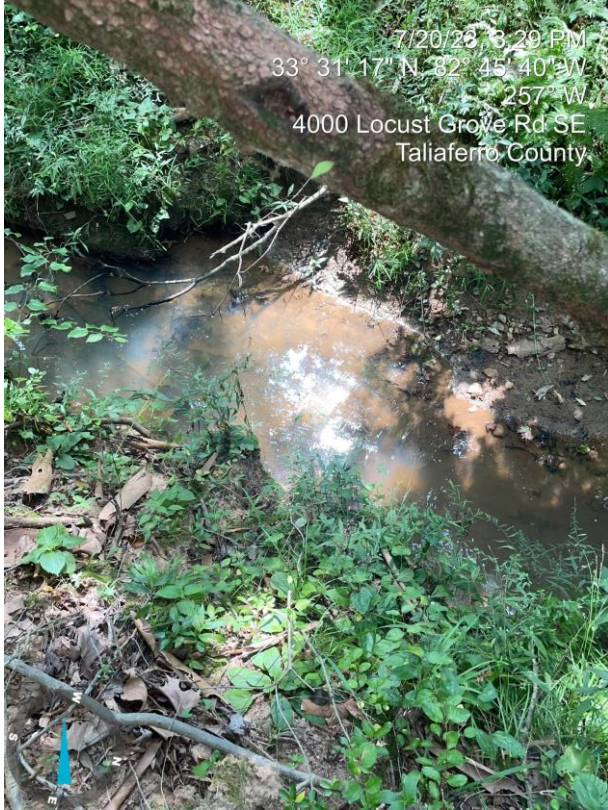
**Photo #15:** 7/20/2023

**Observations:** Photo of creek on the soil amendment property showing discolored creek banks and waters.

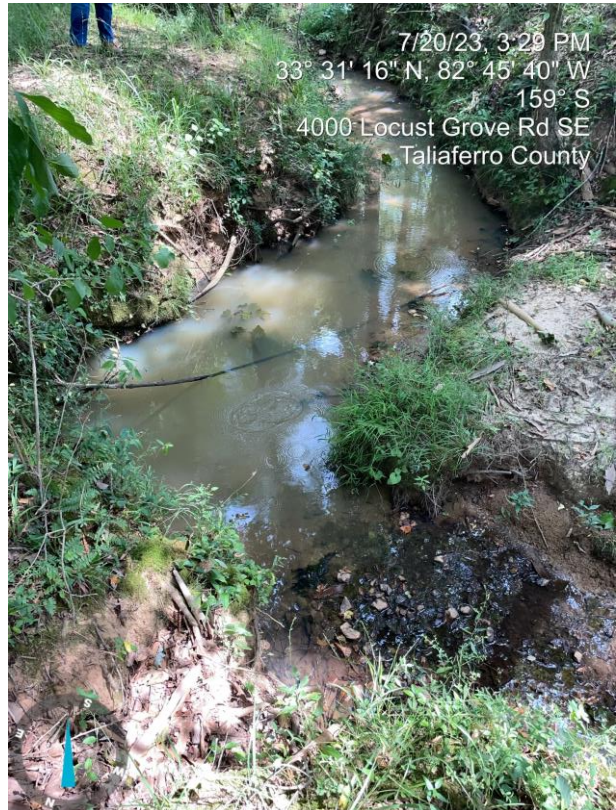
**Photo #16:** 7/20/2023

**Observations:** Photo of creek on the soil amendment property showing discolored creek banks and waters.

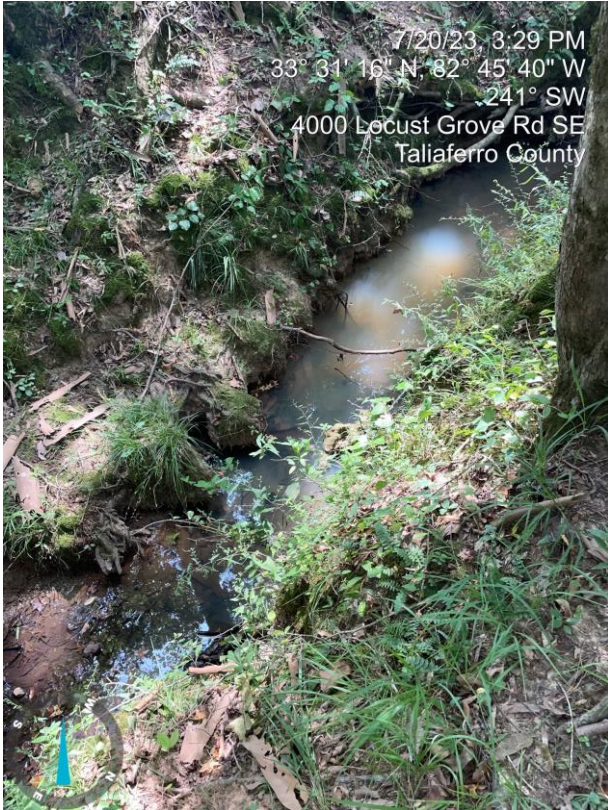
**Photo #17:** 7/20/2023

**Observations:** Photo of creek on the soil amendment property showing discolored creek banks and waters.

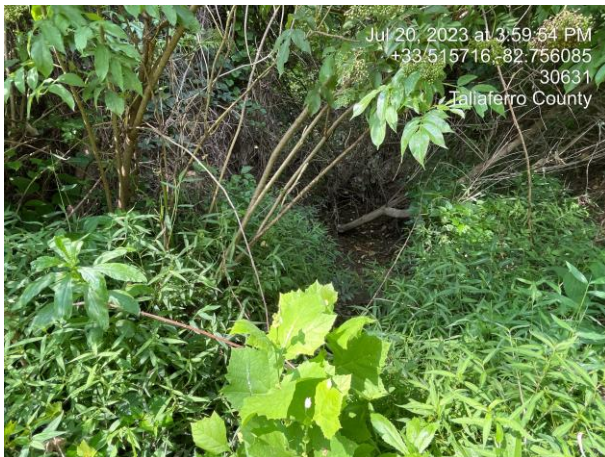
**Photo #19:** 7/20/2023

**Observations:** Photo of a tributary on an adjacent property downstream from the property applying soil amendment.

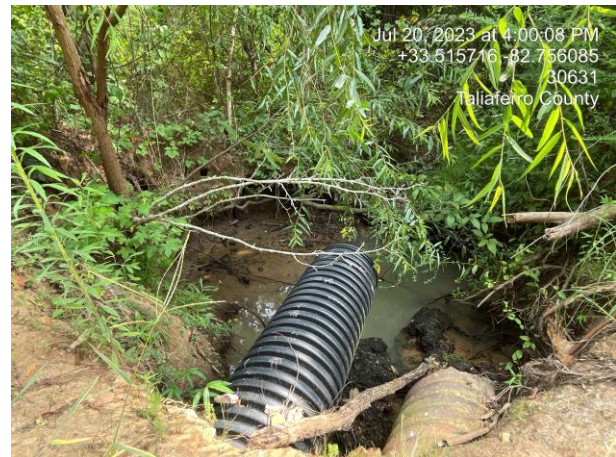
**Photo #20:** 7/20/2023

**Observations:** Photo of a tributary on an adjacent property downstream from the property applying soil amendment.

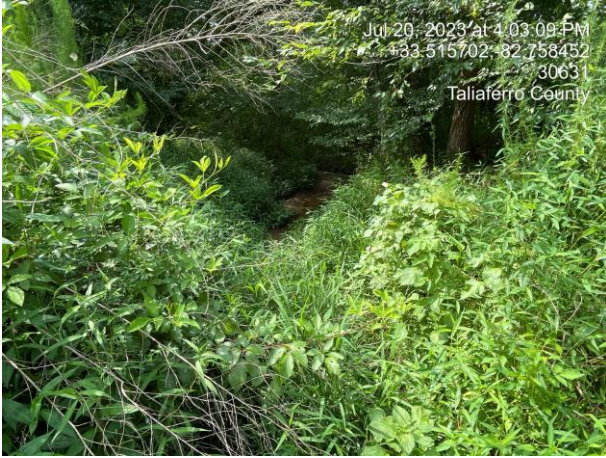
**Photo #21:** 7/20/2023

**Observations:** Photo of a tributary on an adjacent property downstream from the property applying soil amendment.

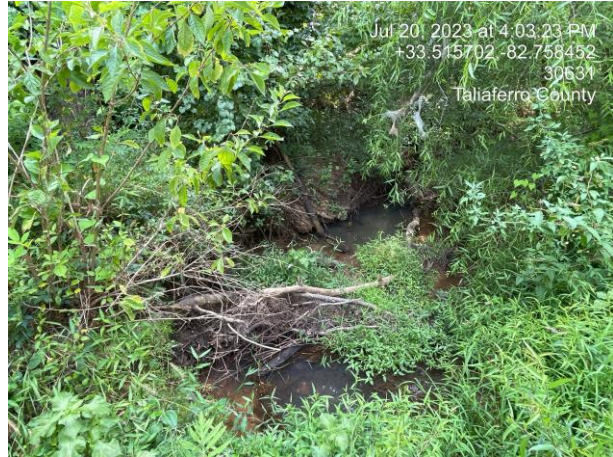
**Photo #22:** 7/20/2023

**Observations:** Photo of a tributary on an adjacent property downstream from the property applying soil amendment.

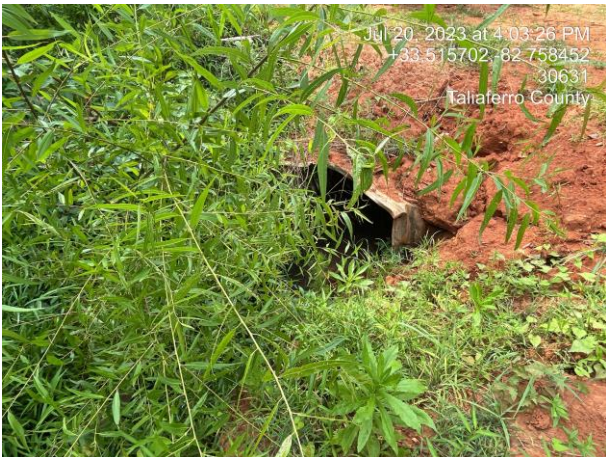
**Photo #23:** 7/20/2023

**Observations:** Photo of a tributary on an adjacent property downstream from the property applying soil amendment.
