Subject: **Limited Stream Assessment**  
Lake Arrowhead, Phase II, Unit 12  
1434 Arrowhead Drive  
Waleska, Cherokee County, Georgia  
Maxis Project No.: 1-25-152A

# Limited Stream Assessment

**1434 Arrowhead Drive, Waleska, Cherokee County, Georgia**

Maxis Project No. 1-25-152A

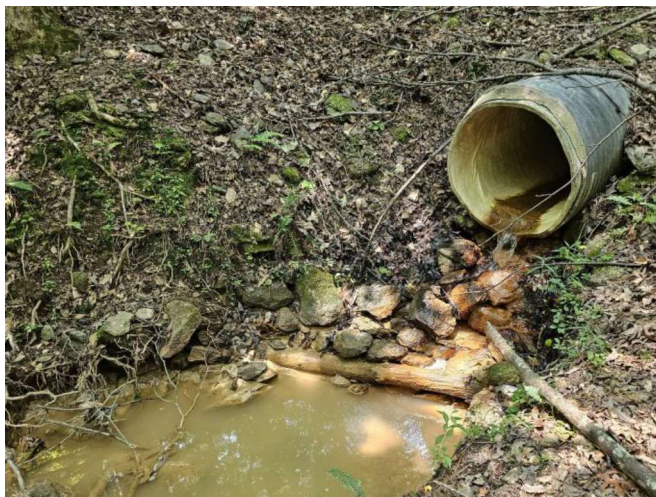
Upstream of Station A-1

| Stream Station | Date Sampled | Readings <sup>(1)</sup> | | | | Fish/amphibians Present<br>(yes/no) <sup>(2)</sup> |
|---|---|---|---|---|---|---|
| A-1 | 06/02/25 | 6.83 | 20.76 | 9.25 | 60.8 | no |

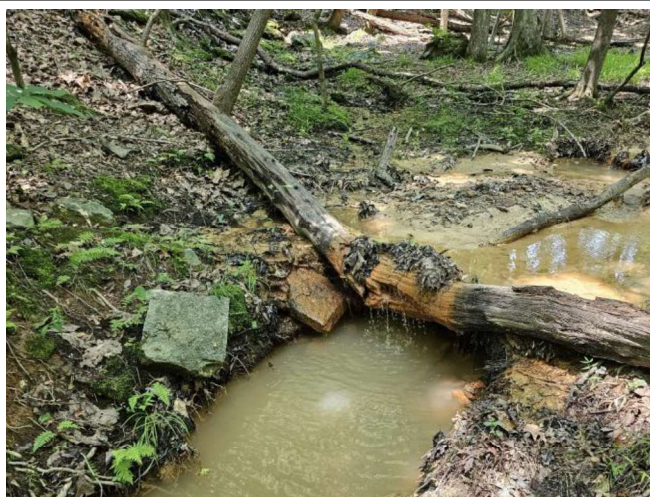
Upstream of Station A-2

| Stream Station | Date Sampled | Readings <sup>(1)</sup> | | | | Fish/amphibians Present<br>(yes/no) <sup>(2)</sup> |
|---|---|---|---|---|---|---|
| A-2 | | 5.92 | 19.68 | 6.85 | 58.9 | no |

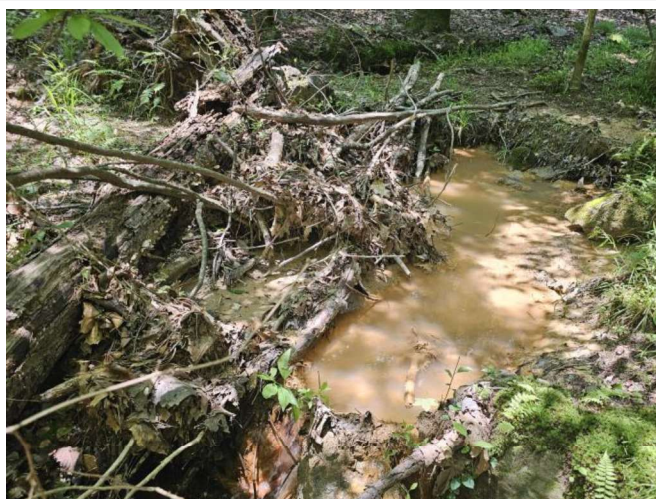
Upstream of Station A-3

| Stream Station | Date Sampled | Readings <sup>(1)</sup> | | | | Fish/amphibians Present<br>(yes/no) <sup>(2)</sup> |
|---|---|---|---|---|---|---|
| A-3 | | 6.09 | 19.45 | 7.96 | 66.5 | no |

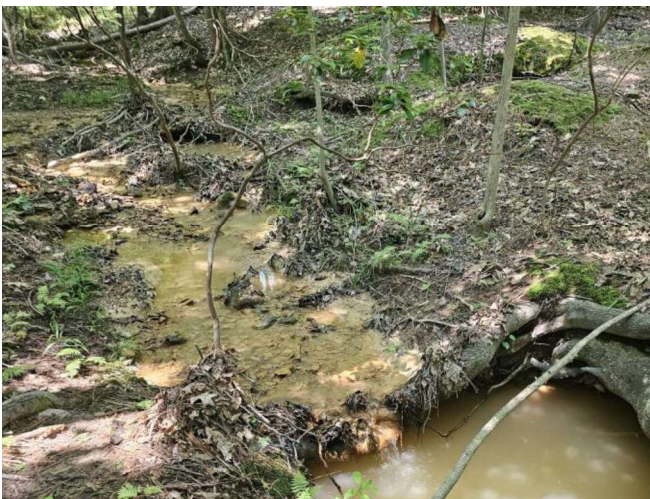
Upstream of Station A-4

| Stream Station | Date Sampled | Readings <sup>(1)</sup> | | | | Fish/amphibians Present<br>(yes/no) <sup>(2)</sup> |
|---|---|---|---|---|---|---|
| A-4 | | 5.92 | 19.58 | 8.94 | 86.1 | yes |

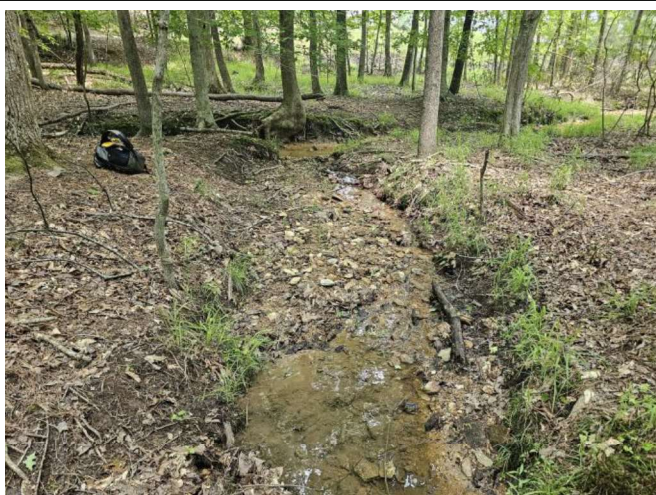
Downstream of Station B-1

| Stream Station | Date Sampled | Readings <sup>(1)</sup> | | | | Fish/amphibians Present<br>(yes/no) <sup>(2)</sup> |
|---|---|---|---|---|---|---|
| B-1 | 06/02/25 | 5.25 | 18.79 | 4.27 | 0.8 | no |

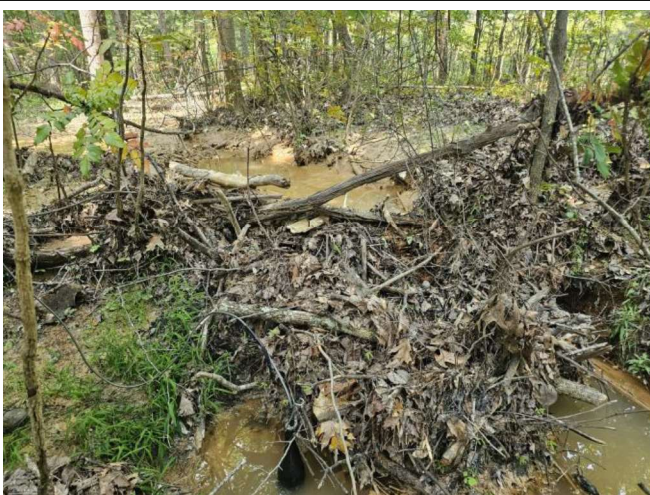
Upstream of Station A-5

| Stream Station | Date Sampled | Readings <sup>(1)</sup> | | | | Fish/amphibians Present<br>(yes/no) <sup>(2)</sup> |
|---|---|---|---|---|---|---|
| A-5 | | 5.97 | 19.78 | 7.24 | 79.4 | yes |

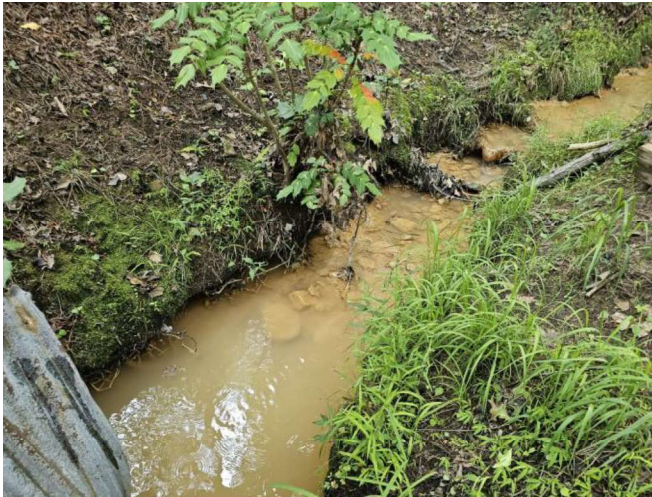
Upstream of Station A-6

| Stream Station | Date Sampled | Readings <sup>(1)</sup> | | | | Fish/amphibians Present<br>(yes/no) <sup>(2)</sup> |
|---|---|---|---|---|---|---|
| A-6 | | 5.82 | 19.81 | 6.55 | 85.6 | yes |

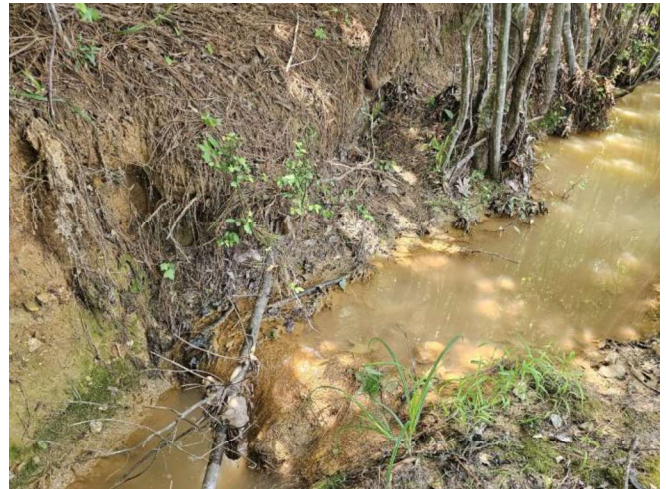
Upstream of Station A-7

| Stream Station | Date Sampled | Readings <sup>(1)</sup> | | | | Fish/amphibians Present<br>(yes/no) <sup>(2)</sup> |
|---|---|---|---|---|---|---|
| A-7 | | 5.85 | 19.51 | 8.14 | 33.6 | yes |

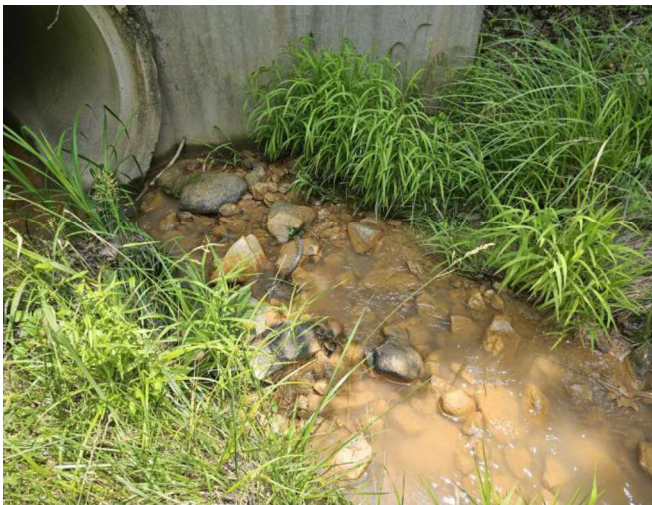
Upstream of Station A-8

| Stream Station | Date Sampled | Readings <sup>(1)</sup> | | | | Fish/amphibians Present<br>(yes/no) <sup>(2)</sup> |
|---|---|---|---|---|---|---|
| A-8 | | 5.83 | 17.21 | 8.66 | 39.0 | yes |

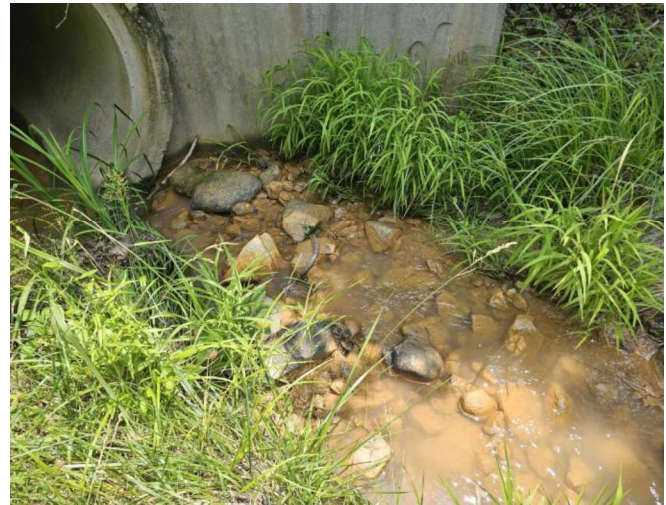
Upstream of Station A-9

| Stream Station | Date Sampled | Readings <sup>(1)</sup> | | | | Fish/amphibians Present<br>(yes/no) <sup>(2)</sup> |
|---|---|---|---|---|---|---|
| A-9 | | 5.83 | 18.72 | 8.67 | 102.0 | yes |

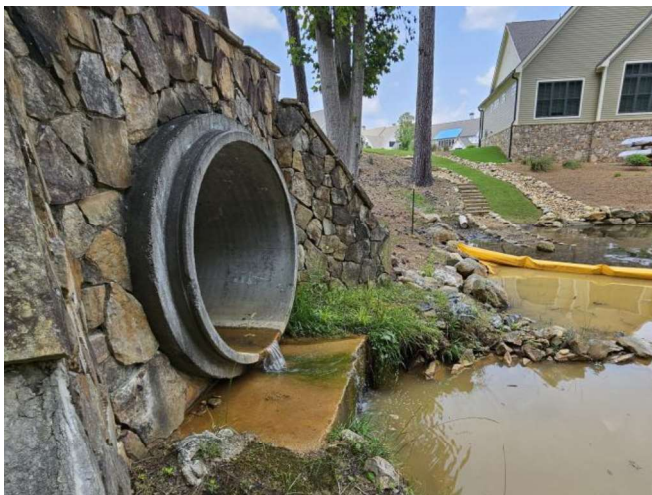
Upstream of Station A-10

| Stream Station | Date Sampled | Readings <sup>(1)</sup> | | | | Fish/amphibians Present<br>(yes/no) <sup>(2)</sup> |
|---|---|---|---|---|---|---|
| A-10 | | 6.18 | 21.79 | 8.84 | 30.9 | no |

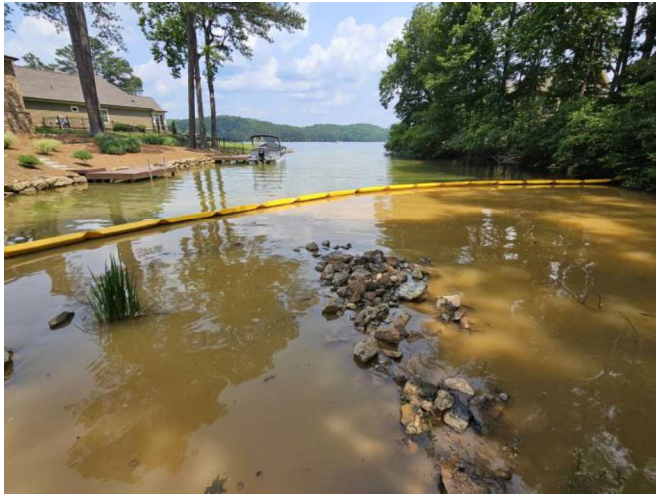
Lake Station C-2

Sediment build-up was observed along the interior section of the turbidity curtain. The turbidity curtain appeared to be successful in temporarily isolating/containing the sediment loss to within the interior of the cove.

| Stream Station | Date Sampled | Readings <sup>(1)</sup> | | | | Fish/amphibians Present<br>(yes/no) <sup>(2)</sup> |
|---|---|---|---|---|---|---|
| C-2 | | 6.11 | 24.70 | 6.96 | 212.0 | no |

Maxis recommends inspecting and demucking of the aforementioned sediment ponds, if necessary, and removing sediment build-up in the cove associated with the turbidity curtain. Additionally, areas of concentrated stormwater flow as evidence of erosion rills and/or gulleys should be addressed with additional best management practices (BMPs), including but not limited to additional mulch/seed/check dams, etc... to stabilize these areas.

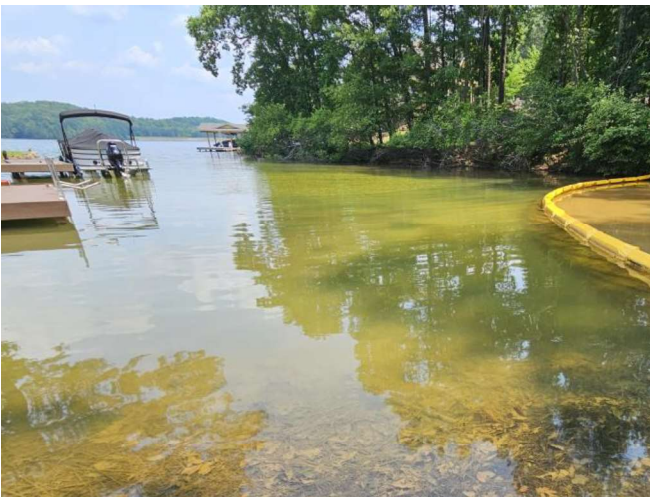
Lake Station C-4

| Stream Station | Date Sampled | Readings <sup>(1)</sup> | | | | Fish/amphibians Present<br>(yes/no) <sup>(2)</sup> |
|---|---|---|---|---|---|---|
| C-4 | | 7.21 | 27.39 | 6.90 | 6.5 | yes |

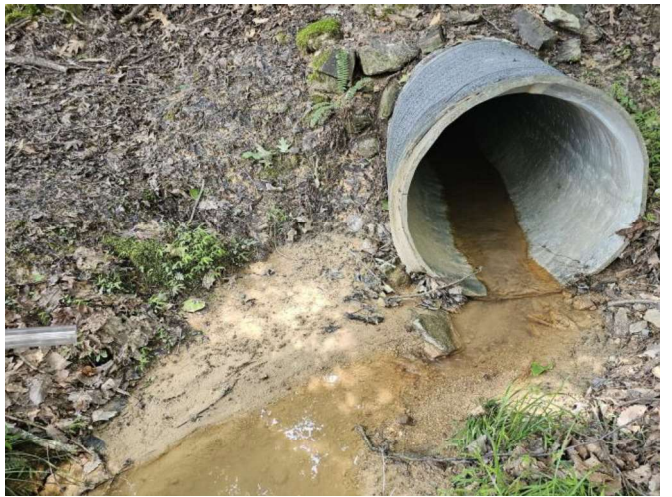
Downstream of Station A-11

| Stream Station | Date Sampled | Readings <sup>(1)</sup> | | | | Fish/amphibians Present<br>(yes/no) <sup>(2)</sup> |
|---|---|---|---|---|---|---|
| A-11 | | 6.49 | 20.42 | 6.56 | 47.0 | no |

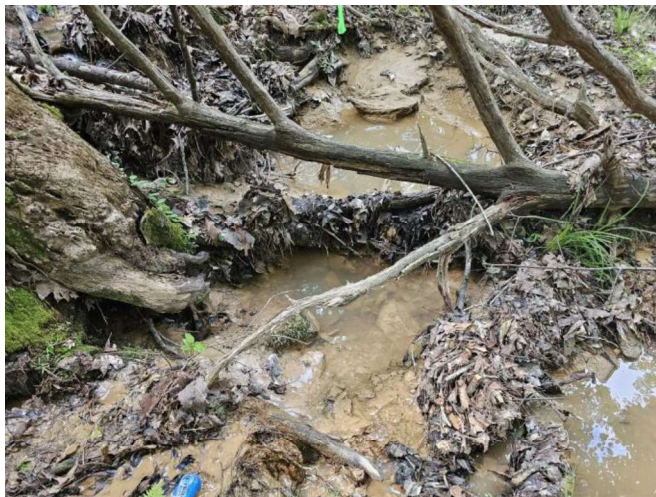
Upstream of Station A-12

| Stream Station | Date Sampled | Readings <sup>(1)</sup> | | | | Fish/amphibians Present<br>(yes/no) <sup>(2)</sup> |
|---|---|---|---|---|---|---|
| A-12 | | 6.43 | 20.70 | 6.24 | 63.6 | no |

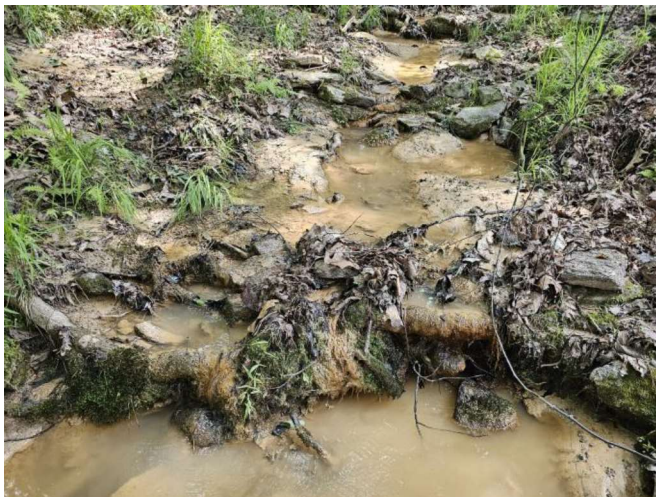
Upstream of Station A-13

| Stream Station | Date Sampled | Readings <sup>(1)</sup> | | | | Fish/amphibians Present<br>(yes/no) <sup>(2)</sup> |
|---|---|---|---|---|---|---|
| A-13 | | 6.60 | 20.49 | 6.46 | 72.0 | no |

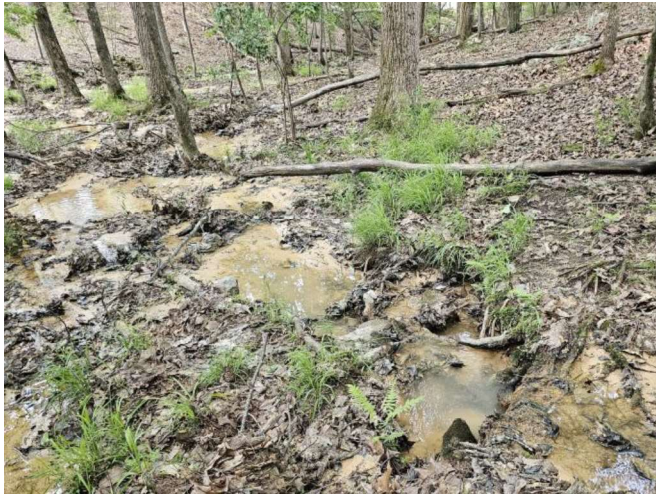
Upstream of Station A-14

| Stream Station | Date Sampled | Readings <sup>(1)</sup> | | | | Fish/amphibians Present<br>(yes/no) <sup>(2)</sup> |
|---|---|---|---|---|---|---|
| A-14 | | 6.58 | 20.42 | 6.07 | 48.1 | no |

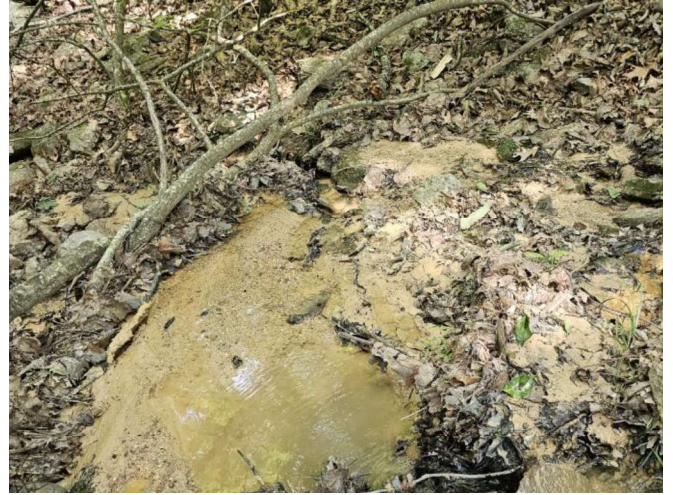
Upstream of Station A-15

| Stream Station | Date Sampled | Readings <sup>(1)</sup> | | | | Fish/amphibians Present<br>(yes/no) <sup>(2)</sup> |
|---|---|---|---|---|---|---|
| A-15 | | 6.64 | 20.92 | 6.27 | 48.7 | no |

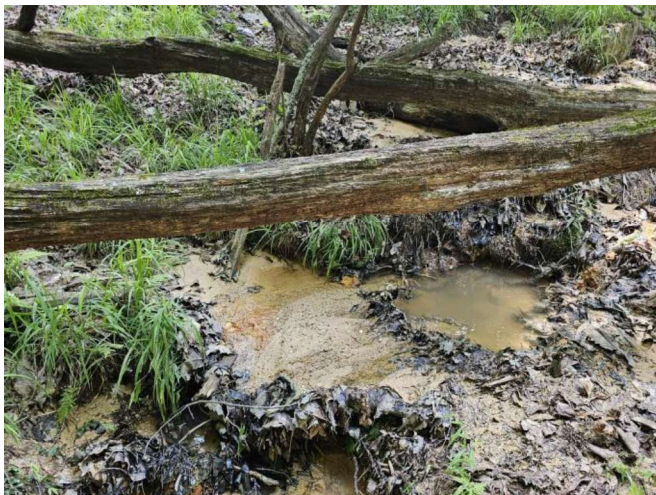
Upstream of Station A-16

| Stream Station | Date Sampled | Readings <sup>(1)</sup> | | | | Fish/amphibians Present<br>(yes/no) <sup>(2)</sup> |
|---|---|---|---|---|---|---|
| A-16 | | 6.69 | 21.67 | 6.46 | 16.9 | no |

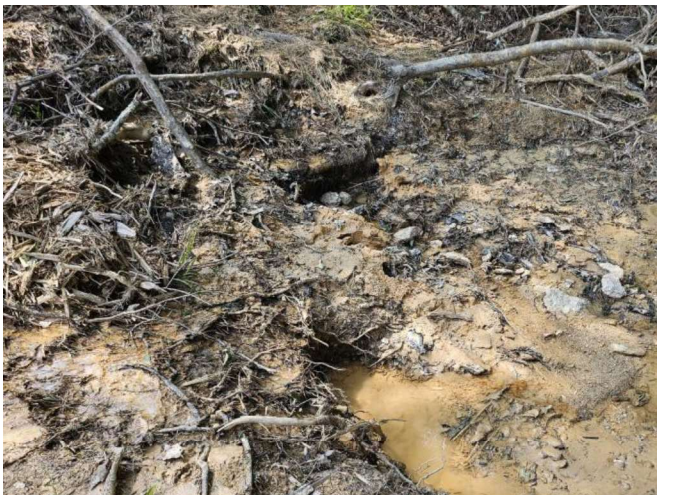
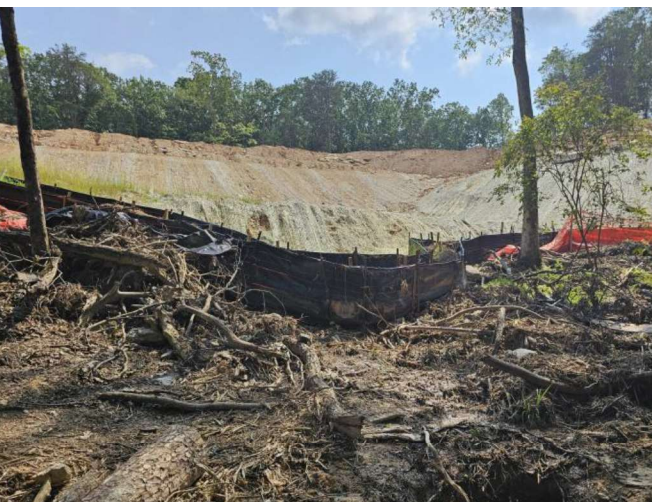
Upstream of Station A-17

| Stream Station | Date Sampled | Readings <sup>(1)</sup> | | | | Fish/amphibians Present<br>(yes/no) <sup>(2)</sup> |
|---|---|---|---|---|---|---|
| A-17 | | 6.01 | 21.84 | 5.47 | 100.0 | no |

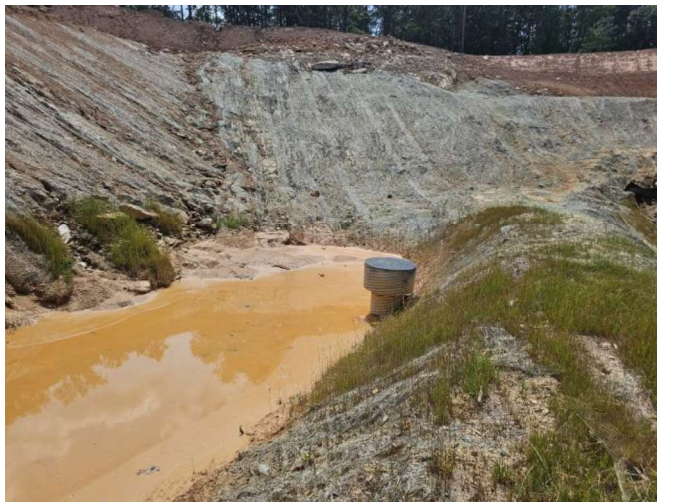
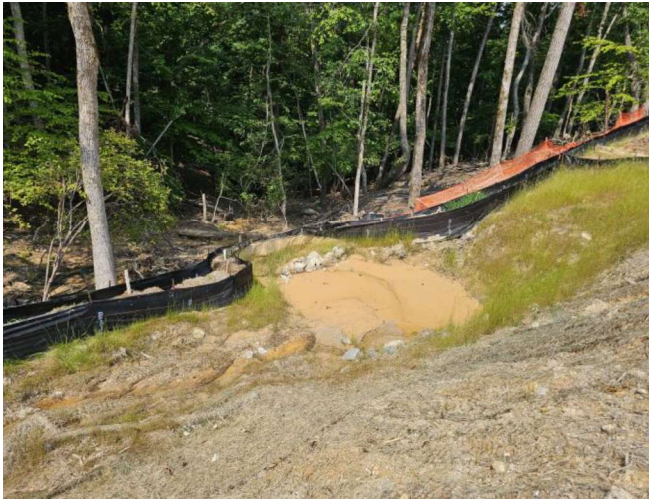
Sediment Basin SD3-7

On June 2, 2025, Maxis reviewed the proposed subdivision and approved grading plans and determined the sediment loss point of impact (POI) appeared to originate directly downgradient of temporary sediment ponds Sd3-7 and Sd4C-8. A third possible location for sediment discharge was identified during the field reconnaissance, which was located downgradient of temporary sediment pond Sd3-16. Sediment associated with the loss appeared to flow east, southeast along Stream A until reaching a cove in Lake Arrowhead.
